INVESTIGATION OF SLIDING WEAR MECHANISM AND CAUSES ON A DIESEL APPLICATION ROLLER FOLLOWER

Rafael Amboss Pinto¹, Avelino Elias Martins de Souza¹,
Vitor Atsushi Shimada¹, Sérgio Medeiros dos Santos²

¹Robert Bosch Ltda.

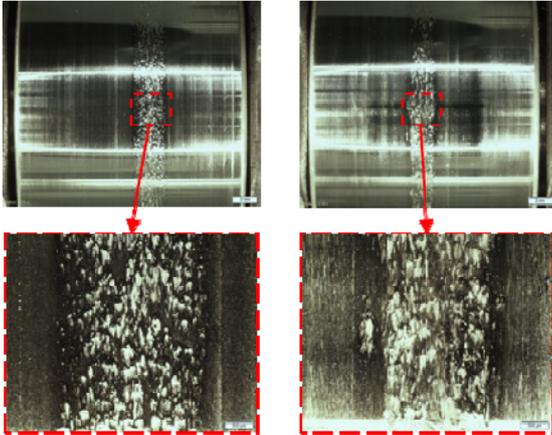
As a validation program for an internal project, tests were carried out to ensure reliability on the follower manufactured on the new production site. One of the tests, carried out on dynamometer by the customer, resulted in excessive wear on 2 from a set of 6 rollers. “Severe wear” is characterized by material removal from the roller track, through formation and progress of contact fatigue pitting or spalling. The maximum admissible wear (“medium wear”) is characterized by initial pitting formation, without evolution over operation time, and

running traces marked on roller track center. The “severely worn” rollers, shown on Figure 3, were from cylinders 1 and 6. The other four rollers from this set presented “light wear”, described as “Slight running traces on the roller track surface”. Figure 4 shows a SEM analysis of the worn rollers, evidencing contact fatigue and plastic deformation, which indicates that sliding between surfaces occurred.

Figure 3 – Stereoscope images from worn rollers: cyl. 1 at left pictures and cyl. 6 at right pictures.

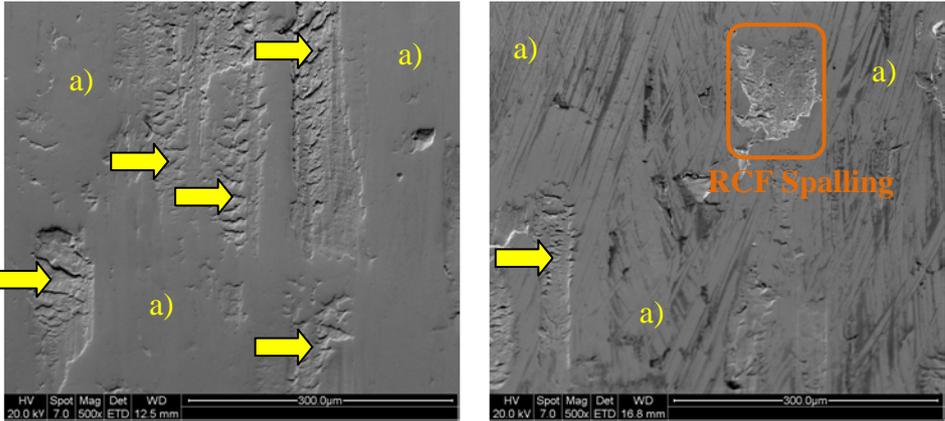
Evidences of sliding wear:

- a) smoothed surface.
- b) shingles due to local seizure with lost material due to adhesion (→)

Figure 4 - SEM images from 2 rollers (cyl. 1, left picture) and (cyl. 6, right picture), pointing the evidences of the wear mechanisms identified.

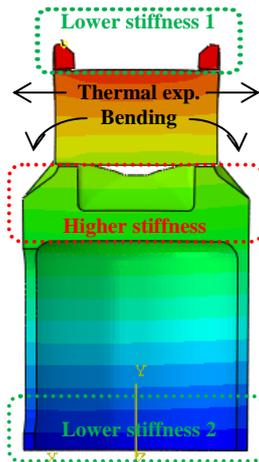
A static FEM simulation was performed to evaluate the follower assembly behavior under heating. On the region "Higher stiffness" from Figure 12, the roundness deviation is smaller than $1\mu\text{m}$. On region "Lower stiffness 2" the follower roundness deviation is around the magnitude of $10\mu\text{m}$ when heated to typical temperature peaks found on engine oil (see b-a on Figure 13). Moreover, peak temperatures are not enough to cause severe thermal deformations, since time is needed for the parts to reach thermal balance. Simulation assumed the peak temperature as constant, being more severe than reality.

Figure 12 – FEM thermal expansion simulation showing bending of axle pin.

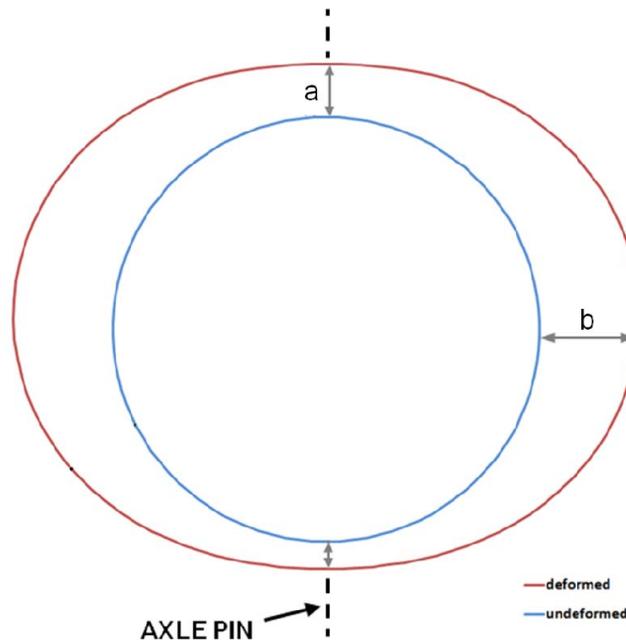
Considering that the guide increases its diameter regularly (perfectly round), the clearance tends to decrease on “Lower stiffness 2” region. The clearances between follower and its guide are usually at the magnitude of $60\mu\text{m}$ on both “Lower” and “Higher” stiffness regions. The tolerance combination of extreme values for diameters allows clearances as low as the magnitude of $20\mu\text{m}$. The process has high capability, thus it is known that extreme tolerance values in combination have very low probability to happen. Hence, to evaluate the real possibility of the follower to get seized on the guide, a stack-up analysis was made to compare the simulated clearance after typical peak temperature of engine oil (taking into account the roundness deviation and thermal expansion of follower and its guide) to the ambient temperature condition. The real capability of the follower diameter was considered, while a conservative value was assumed for the guide capability. In this way it is possible to quantify the real clearance being manufactured, while the “extreme tolerance approach” would be too conservative.

Figure 13 – Follower body thermal deformation on region identified as “Lower stiffness 2” from Figure 12.

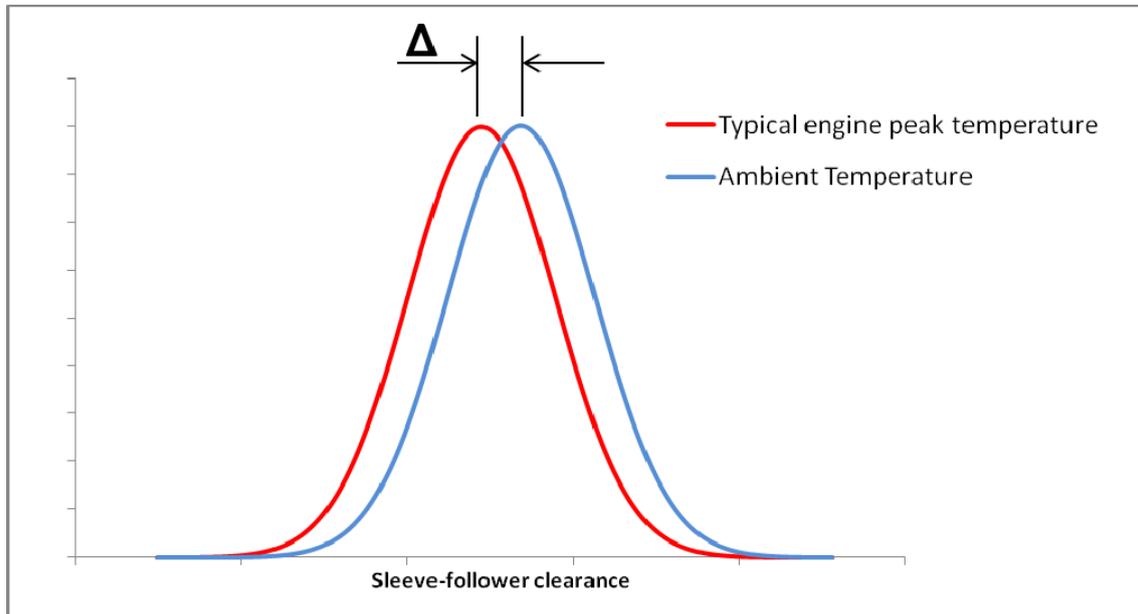
The result of the stack-up analysis is shown on Figure 14. The normal distributions for clearance at ambient temperature and for clearance at simulated typical peak temperature of engine oil were plotted together. It can be stated that the roundness deviation at the typical peak temperature of engine oil tends to reduce the clearance only by some micrometers (Δ), comparing to the ambient temperature condition. The influence on guide/follower friction coefficient is insignificant for such a slight reduction. The probability of having the clearance equal to zero is not significant. Moreover, the guides and followers only presented light wear.

Figure 14 – Normal distribution for clearance at ambient temperature and after typical engine oil temperature.

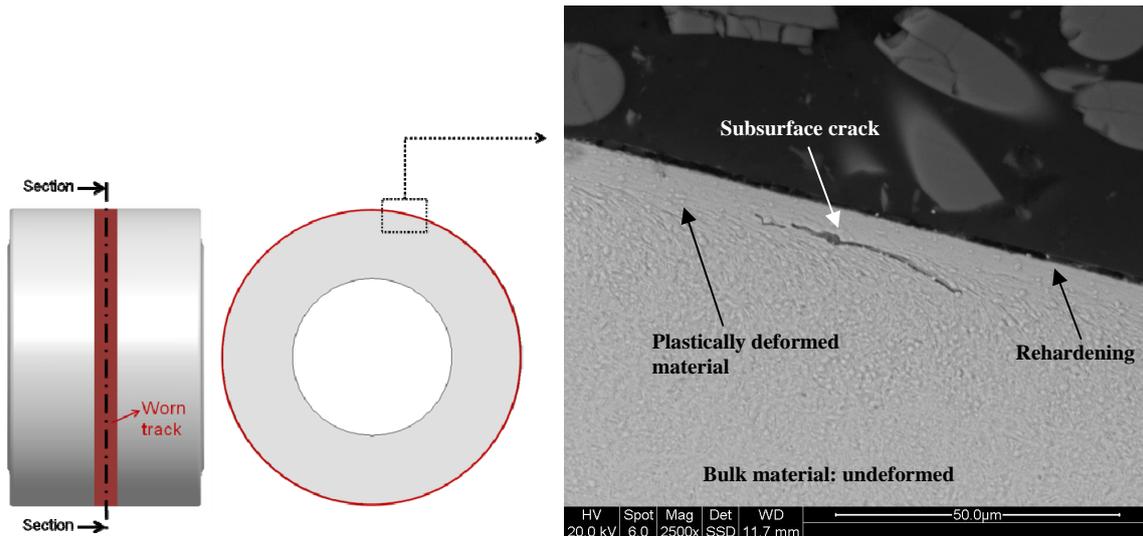
Figure 15 – SEM picture from transverse section parallel to rolling movement of roller, showing the plastically deformed material described on Figure 6 and the subsurface crack formation.

Cracks formation at the subsurface, through contact fatigue form 1 (discussed on “Theoretical basis” section) is present on Figure 15. Wear by contact fatigue with pitting originating on the surface [5], form 2 of contact fatigue, is evidenced on Figure 16. Both figures show a section of the roller, parallel to its rolling direction. If the test has continued, the crack on Figure 15 would propagate through mode II and reach the surface, releasing a particle and forming a spall. Inadequate lubrication can be one leading factor to these forms of contact fatigue.

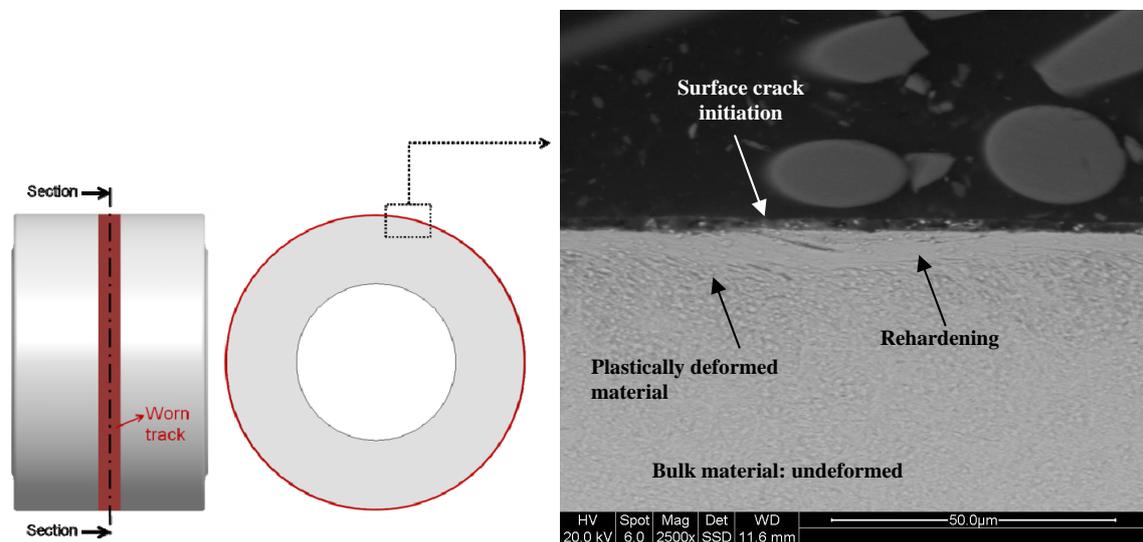
Figure 16 – SEM picture from transverse section parallel to rolling movement of roller, showing the plastically deformed material described on Figure 6 and the surface pitting formation.

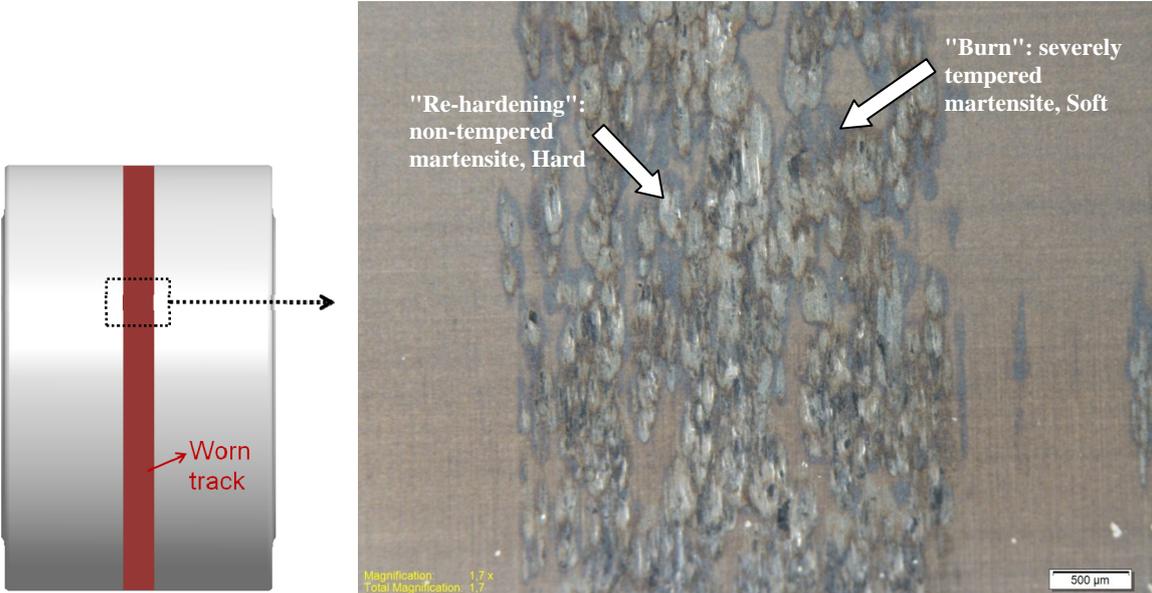
At the Material Laboratory the roller worn surface was manually polished, etched with Nital and observed on a multifocal stereoscope. An evidence of roller/cam slipping is depicted on Figure 17. Roller/cam slipping increases the local temperature severely. The roller was stuck on axle pin and slipping occurred intermittently, evidenced by the discrete worn sites. These worn sites appear in lighter color due to presence of non-tempered martensite (hard). Around the non-tempered martensite sites, the dark color evidences regions where the temperature was high enough to temper severely (causing soft spots), but not to austenitize and reharden. This interface of a hard microstructure (non-tempered martensite) with a soft microstructure

(severely tempered martensite) is likely to form cracks and start contact fatigue spalling. The crack may start on surface or below it, but in both cases it leads to spalling formation and material removal.

Figure 17 – Optical stereoscope picture from the top of worn roller track, polished and etched with Nital, showing rehardened regions (non-tempered martensite, hard) and burn regions (severely tempered martensite, soft).

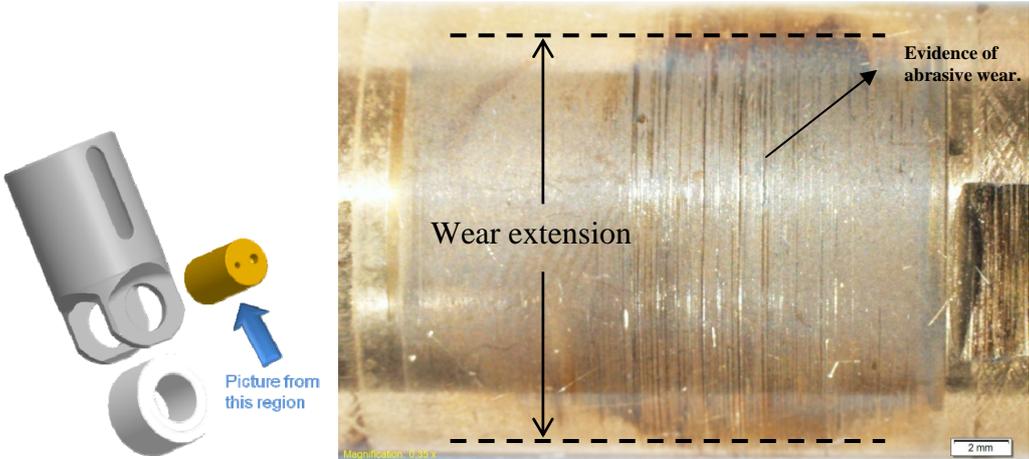
Analyzing the axle pins, the grey region extends for almost its semi perimeter, starting from the lower region, where more intense contact with roller occurs (Figure 18). This is another evidence of roller sticking.

Figure 18 – Picture from multifocal stereoscope, showing the worn region of axle pin extending nearly to the semi perimeter. Abrasive wear due to particles was also observed.

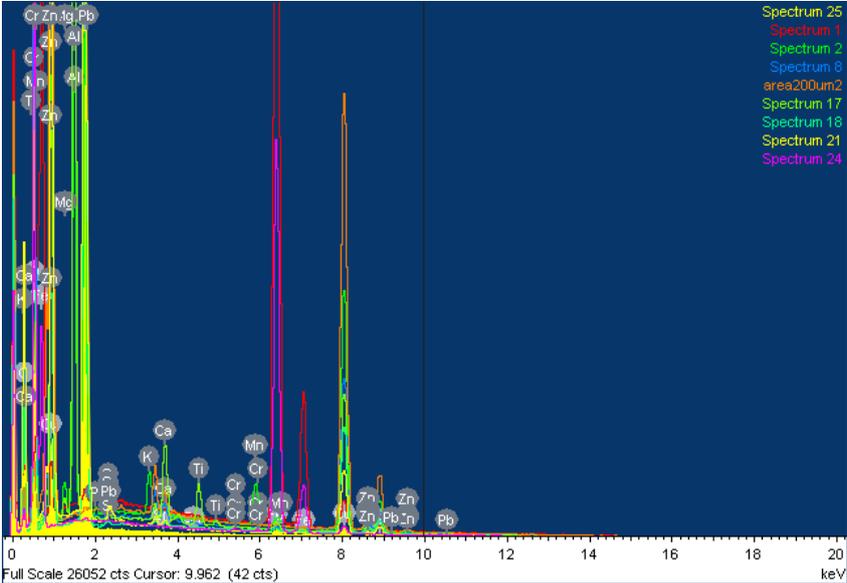
An EDS composition analysis was performed, to identify the elements present on the particles attached to the axle pins. Four axle pins were analyzed, from the two worn rollers and from two rollers that passed the tests. All of them presented aluminum particles, one example can be seen on Figure 19. Figure 20 shows the SEM analysis of an axle pin from the same test and the particle identified as aluminum.

Figure 19 – EDS analysis of axle pin from a worn roller, exactly on one of the particles shown on SEM analysis at Figure 20.

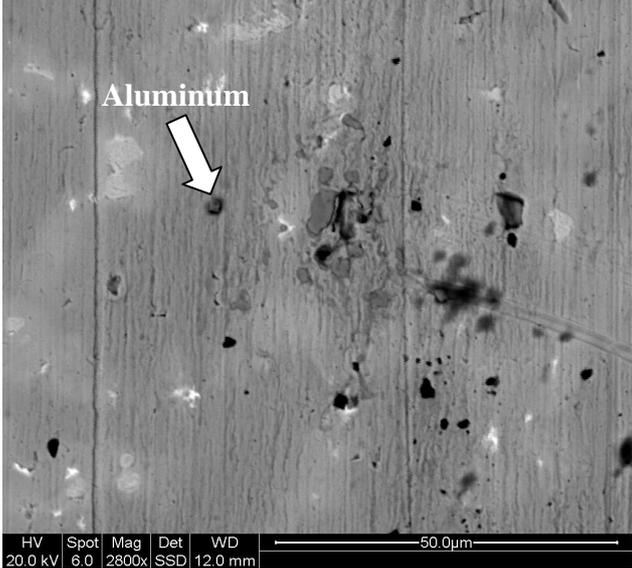
Figure 20 – SEM analysis of axle pin, pointing the Al particle.
