# Evaluation of the energy performance of stilt houses (palafitos) of the Chiloé Island. The role of dynamic thermal simulation on heritage architecture.

*The stilt houses on Chiloé Island, Chile, traditionally built in local timber, are currently in poor conditions and lack of maintenance that contributes on a very poor thermal performance. To carry out interventions and inform decision making to intervene on such unique pieces of cultural heritage in fragile conditions, a computerized dynamic thermal simulation tool (software DesignBuilder®) is used to understand and assess the energy performance of these typology of houses, identifying their annual energy losses, and determining their current annual heating demand of ten case studies. The current annual heating demand of the stilt houses is high, due to the thermal transmittance values of the building envelopes. They exceed in five times the value recommended by Chilean Building Code for the climatic zone under study. Especially critical are heat losses through the ventilated floor (external floor under DesignBuilder® template) and air infiltration, which on average contributed to 30.5% and 28.85% of all energy loss, respective

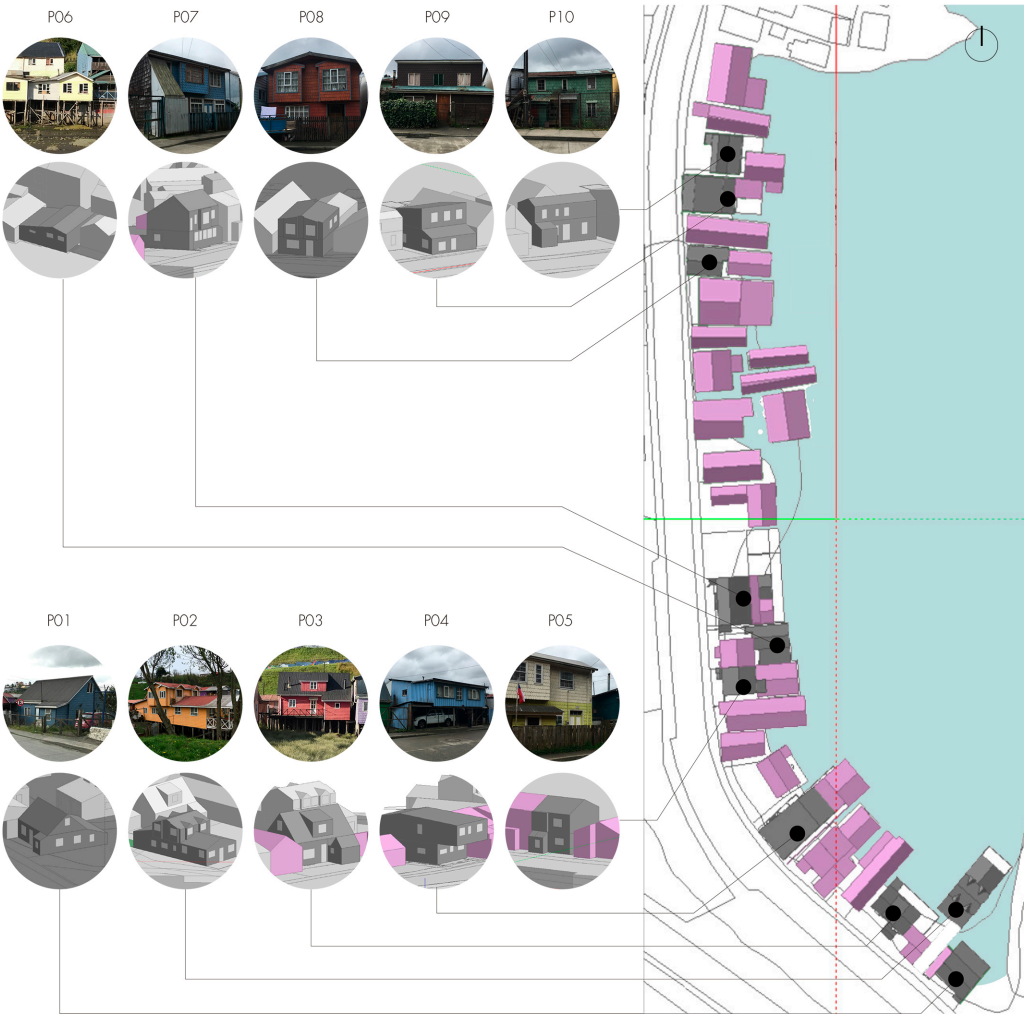
Figure 1  
3D model of  
DesignBuilder and  
photographs of stilt  
houses.

Out of 32 stilt houses, to represent the historical, architectural, morphological, and construction typology ten were selected. They were 3D modeled in the software **DesignBuilder® version 5.0.3.007** and **EnergyPlus version 8.5**. (figure 1)

The DesignBuilder® model (figure 1) includes climate, orientation, room's zones, activities, HVAC, and different building materials used in the envelope, including walls, ventilated floor, ceilings, and openings of each stilt house, as well as the current air infiltration level in air changes per hour (ACH). A diagnosis of the current thermal transmittance of walls, floors and ceilings, heat energy loss, and annual heating demands also be performed.

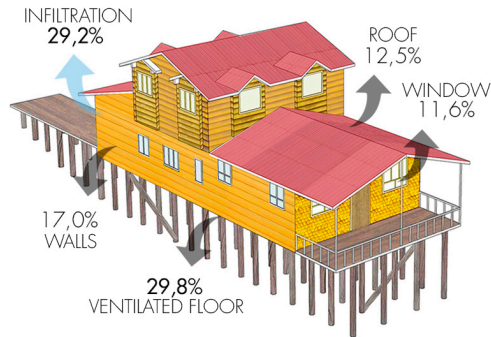
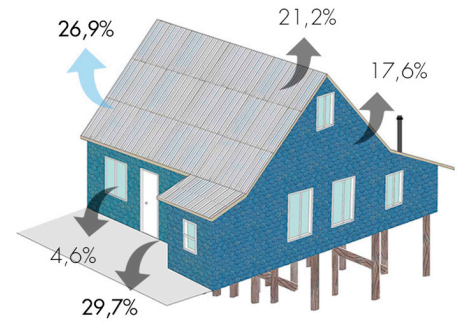
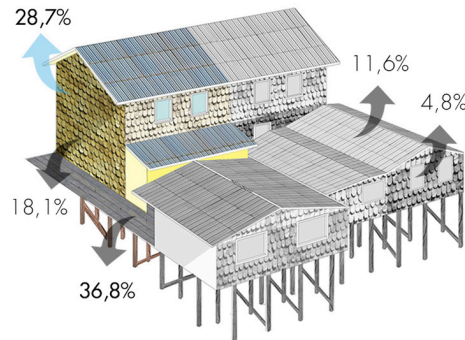
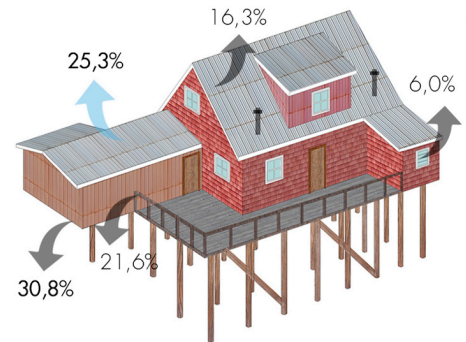
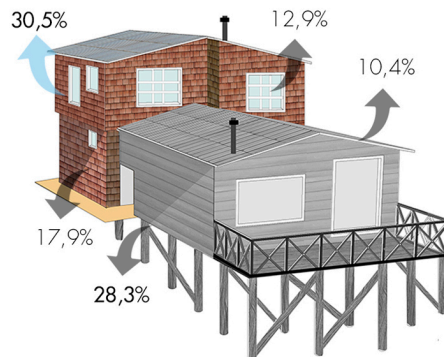
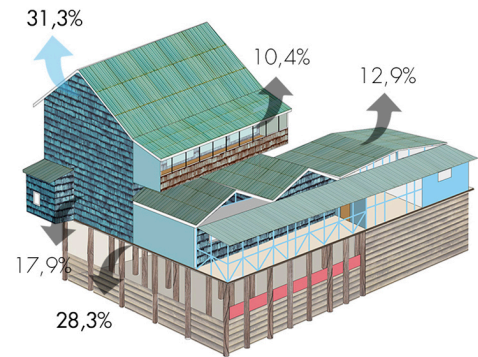
Figure 2  
Graphic diagrams.  
Losses of energy of  
walls, ventilated  
floor, roof, windows  
and infiltrations of  
six stilt houses.

Counting on the current thermal performance of stilt houses and its walls, ventilated floor and roof helps to visualize improvements in the thermal envelope and highlight the energy loss and the reduction of the annual heating demand. (figure 2)

The graphic diagrams are to show occupants about the current condition of their homes, with the purpose of involving and informing them about the benefits of rehabilitating their homes. (figure 2)

3.0 ACH per each stilt house. For the ventilated floors the energy loss has an average of 30.25% , due to the poor building materials conditions and their badly built construction using traditional techniques. Such results are evidenced through thermal infrared imaging taken underneath the kitchens rooms (figure 6), which are the traditionally heated areas (Sahady, 2014). Meanwhile, an average of nearly 18.02% of heat is lost through walls, 15.32% through roofs and 7.54% through openings (doors and windows), the latest is due to the small dimensions compared to the wall's areas. (figure 2, 4)

Last, reconditioning the three building component, walls, ventilated floors, and ceilings (**S5**) would allow up to 65% less energy loss, considering the limit of 1 ACH (n4). As for annual heating demand, up to 66,98% of the current demands, or 70 kWh/m<sup>2</sup> on average, could be lowered. (figure 2, 5)

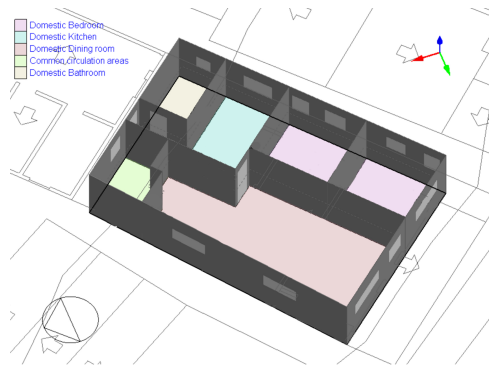
Figure 3  
DesignBuilder's  
templates as  
"residential spaces"

**Rooms, activities, HVAC, and materials of the building envelope..** The rooms of stilt houses are interpreted considering DesignBuilder's templates as “residential spaces” (figure 3), since the houses are not subject to any other large-scale commercial or tourist uses. The templates also indicate the activity level of the occupants, which has tended to be passive and static due to the cold, rainy climate in which occupants have historically gathered around heat sources located in the kitchen or dining room, if not both.

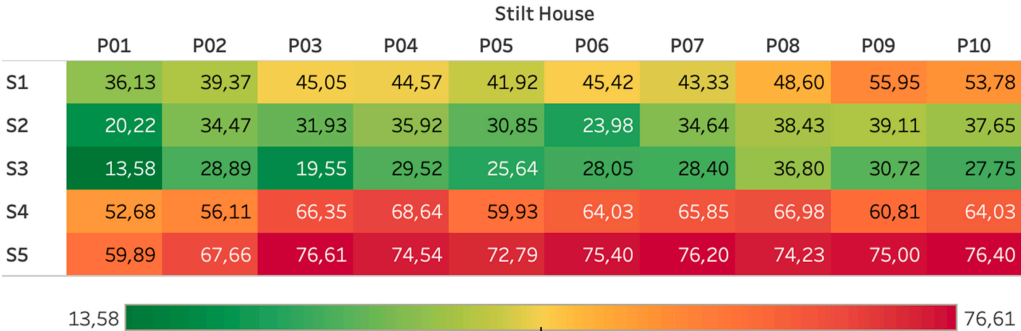
Figure 5  
Reduction in annual  
heating demand.

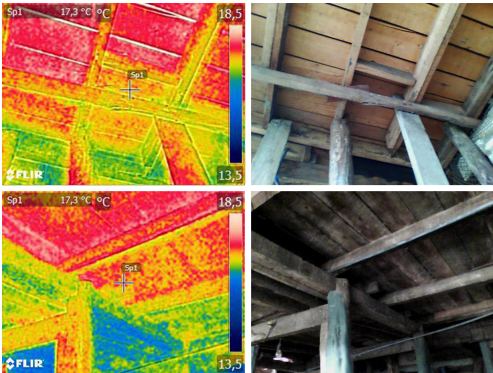
Figure 6  
Thermal infrared  
imaging taken  
underneath the  
kitchens rooms.

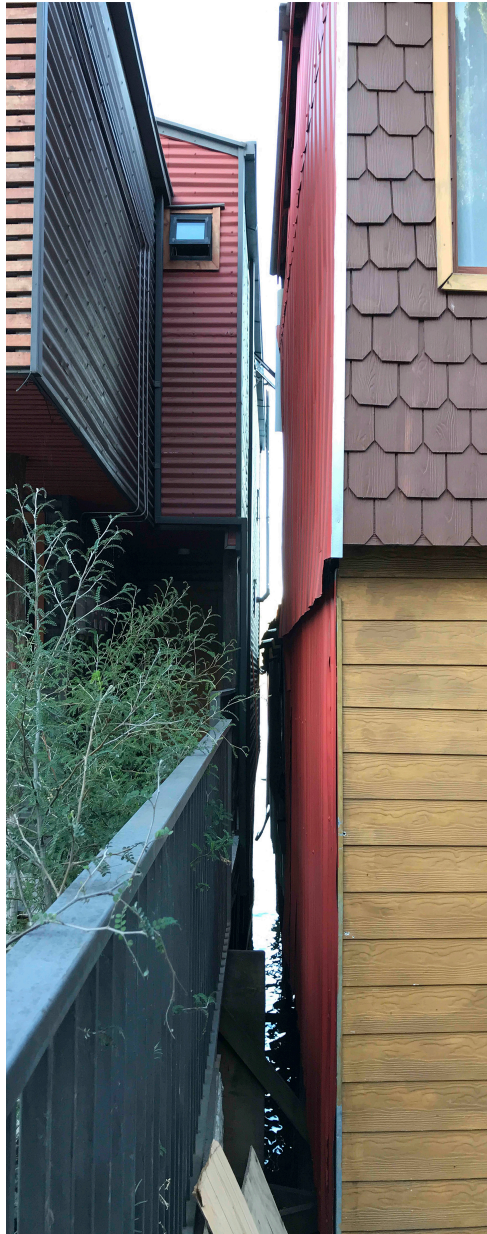
Figure 7  
Narrow space  
between stilt  
houses.

Because each stilt house presents unique construction and morphological qualities, the solutions projected by the simulations often conflict with the economic reality and physical limitations in realizing what the simulations project, especially without jeopardizing the heritage-related value of the houses, which is intrinsic in their kind of housing typology. For example, the narrow space between one house and another makes it impossible for people to gain the access needed to replace elements of the enclosure. (figure 7)
