ENGINE LOW PERFORMANCE CAUSED BY DIESEL BS 500

Sergio Roberto Amaral¹, Ricardo Alexandre Sassa², Fabio Novaes Limeira³, Rogério Curty Dias⁴, Rafael Sorgini Manfredi⁵, Marcos Marcondes⁶

Volkswagen Truck & Bus¹
Volkswagen Truck & Bus²
Volkswagen Truck & Bus³
Volkswagen Truck & Bus⁴
IAV⁵
TECCOM⁶

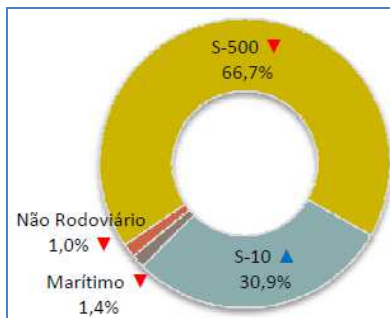
Grahic 1. The graphic represents the percentage of total fuel distributed in Brazil in 2016, according to ANP (see <http://www.anp.gov.br>).

According to ANP Management Bulletin 53 in December'16 the market share regarding BS 500 represents 66,7% of all diesel distributed in the Brazilian Market (see graphic 1). In order to attend the Euro V Emissions requirements the engines must be validate with worst diesel distributed. Then, durability has been done by Engineering Area evaluating performance, fuel consumption and fuel system components specially injectors. The comparison between BS 10 as usual test requirement that assure same conditions for engine approval. In November'2014 the biodiesel percentage was changed from 5% to 7% and from 7% to 8% in March'2017 according to the Law 13263/16. During engine validation tests started in October'2016, it was

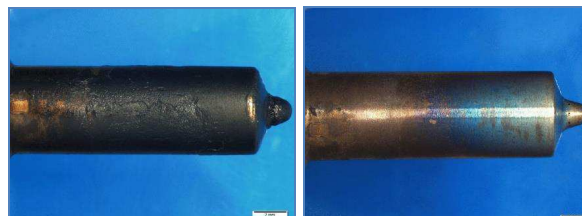
During the engineering development test with Diesel BS500 it was detected a performance losses after 2300 km. It was evaluated at the beginning the fuel injectors. The result shows overheat in three of six the injector nozzles (see picture 1). Then, was decided to replace all injectors and restart the tests. After running 1500 km new performance losses happened and the injectors were analyzed again. The injector's analysis results shows overheat and contaminations (see picture 2).

Picture 1. The picture shows the injector nozzle #5 after 2300 km tested before and after cleaned. The results inform overheating and contamination.

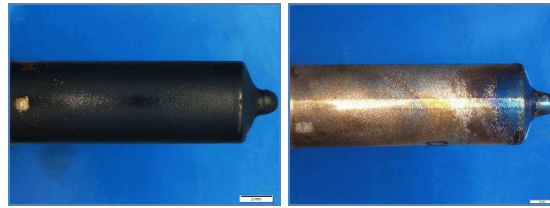
Picture 2. The picture shows the injector nozzle #3 after 1500 km tested before and after cleaned. The results inform overheating and contamination.

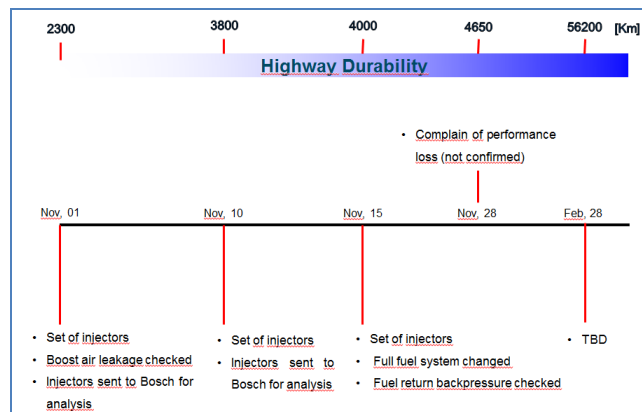
The failure timeline was done in order to keep easy to follow the sequence of occurrences during the highway durability test (see picture 4).

Picture 4. The picture shows the failure timeline with mileage for each failure, parts replaced and analysis definition.

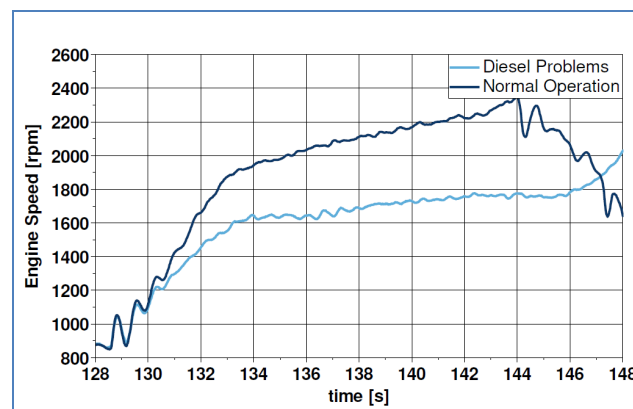
It was confirmed after the injector nozzles replaced no performance problem was detected. The vehicle was instrumented and it covers all engine data and keeps the same durability test until 56200 km when new performance loss was noticed. The comparison was done at ramp test with 20% of inclination and the test starts around 1000rpm at 3rd gear and push full throttle and at the end of ramp must have minimum 2000 rpm. The graphic 2 represents the difference between performance ok and performance loss.

Graphic 2. The graphic shows the vehicle's performance with a normal condition and with performance loss.

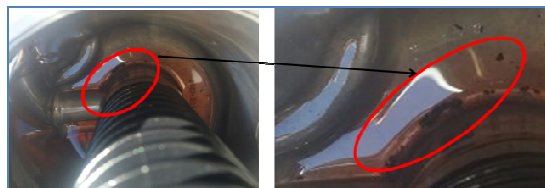
After performance test done it was decided to verify the fuel appearance visually. The main fuel filter was disassembled in order to see the filtering element and it was possible to see a lot of sediments inside of the fuel housing and the new element with 6000 km shows sediments fixed on the element media (see picture 5). The comparison of the vehicle with the

Picture 5. The picture shows sediments inside of main filter housing with Diesel BS 500.

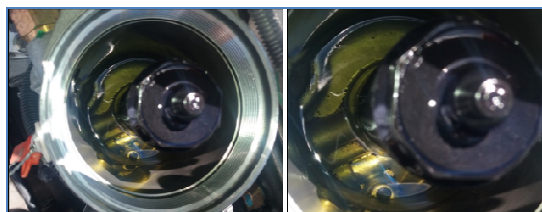
same 6000 km using the BS10, the filtering element looks totally new. The main filter was disassembled and the fuel housing looks new as well (see picture 6). The filtering element was compared with same mileage vehicle but with diesel BS 10 (see picture 7). It was decided to collect fuel from vehicle's diesel tank and it was seen a lot of sediments inside it (see picture 8).

Picture 6. The picture shows normal main filter housing with Diesel BS 10.

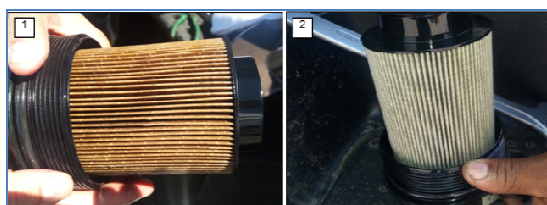
Picture 7. The picture shows: 1) Filtering element with 6000 km tested with BS500; 2) Filtering element with 6000 km tested with BS 10.

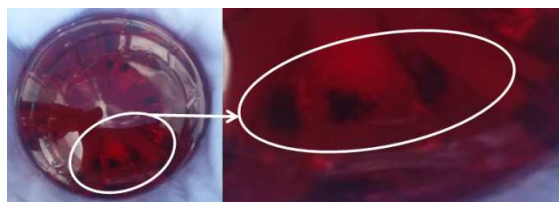
Picture 8. The picture shows sediments inside of fuel tank fueled with diesel BS 500.

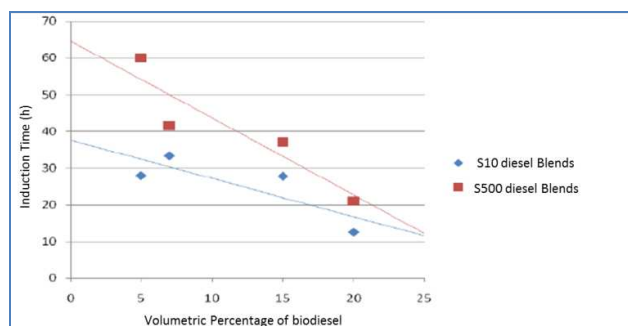
73/2014/SBQ/RJ the minimum oxidation stability in hours to B100 (only biodiesel) is 8 hours and diesel with 7% of biodiesel must has minimum 20 hours for oxidation stability, according to ANP Resolution #30 in June 23th of 2016 and published at Union Official Diary (DOU) in June 27th of 2016 using Rancimat modified method EN15751:2014. According to Researches published at International Symposium of Automotive Engineering (SIMEA/16 – PAP67 – 2016) the diesel was mixed with biodiesel in laboratory (with controlled condition) the Rancimat method can be used to analyze diesel blends of S10 and S500 BX (see graphic 3).

Graphic 3. The graphic shows oxidative stability at 110°C by Rancimat EN15751:2014 at diesel/biodiesel blends (Paper published at SIMEA/16 - PAP67-2016 – Estudos da Adição de biodiesel no diesel S10 e S500 e seus efeitos nas propriedades do combustível e na atomização).

It is possible to understand with graphic 3 why all engine validation tests with BS 500 never show any problem at fuel system (low pressure and high pressure side) caused by biodiesel percentage up to now. The oxidation stability by Rancimat EN15751:2014 is highest than BS 10 with B7 and B8 and it's basically that no injectors nozzles failures were noticed.
