Design Optimization to Reduce Corrosion in Electric Flex Fuel Pump

Vinícius Araújo Peres
Lázaro Benedito de Oliveira Melo
Luiz Eduardo de Azevedo Fernandes
Robert Bosch Ltda.

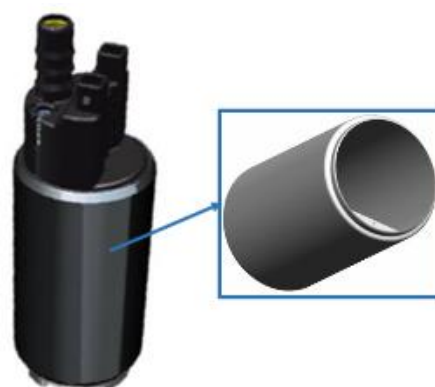
FUEL PUMP HOUSING – As it works through an input voltage and has several metallic components, the fuel pump can be subject to corrosion caused by electrolysis. One of the most susceptible components to this phenomenon is the fuel pump housing, which can be seen in Figure 2. The main functions of the fuel pump housing are:

- Ensure the internal sealing so that there are no leaks during the operation of the fuel pump.
- Fix the components inside of the pump.
- Ensure magnetic flux.

Figure 2. Fuel pump housing

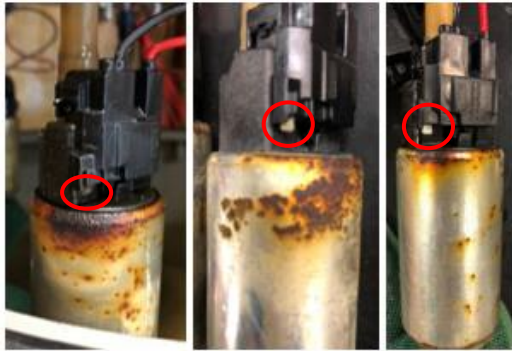
Despite the fact that no field failures resulting from fuel pump housing corrosion have been reported, the appearance of corrosion during durability tests with aggressive ethanol is known, as depicted in Figure 3. Even though corrosion is expected, as these are tests that aim to stress the fuel pump, the distinctive pattern and concentration of corrosion observed on the housing are unexpected. It can be observed from Figure 3 that there are corrosion points along the entire housing, but also a

corrosion accentuated in a specific region, located at the upper side.

Figure 3. Corroded housings in durability tests

GROUNDING TERMINAL - Near this corroded region, there is an exposed grounding terminal, delineated by a red circle in Figure 3, which maintains an electrical connection with the negative wire of the electrical connector. The main functions of the electrical connector are:

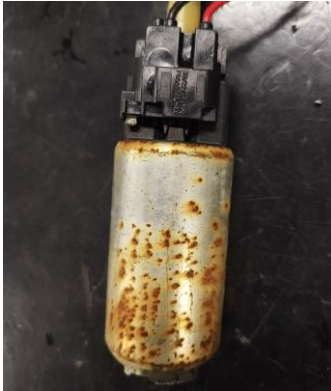
To accomplish this, the Python programming language [9] and the OpenCV library [10] were employed. The methodology will be explained using the corroded housing in Figure 8 as an illustrative example. In order to simplify the corrosion quantification process, only images capturing the side of the housing containing the grounding terminal were considered. This delimitation is reasonable as the opposing side typically exhibits minimal or no corrosion. Therefore, when referring to the housing area, it

Figure 8. Original image

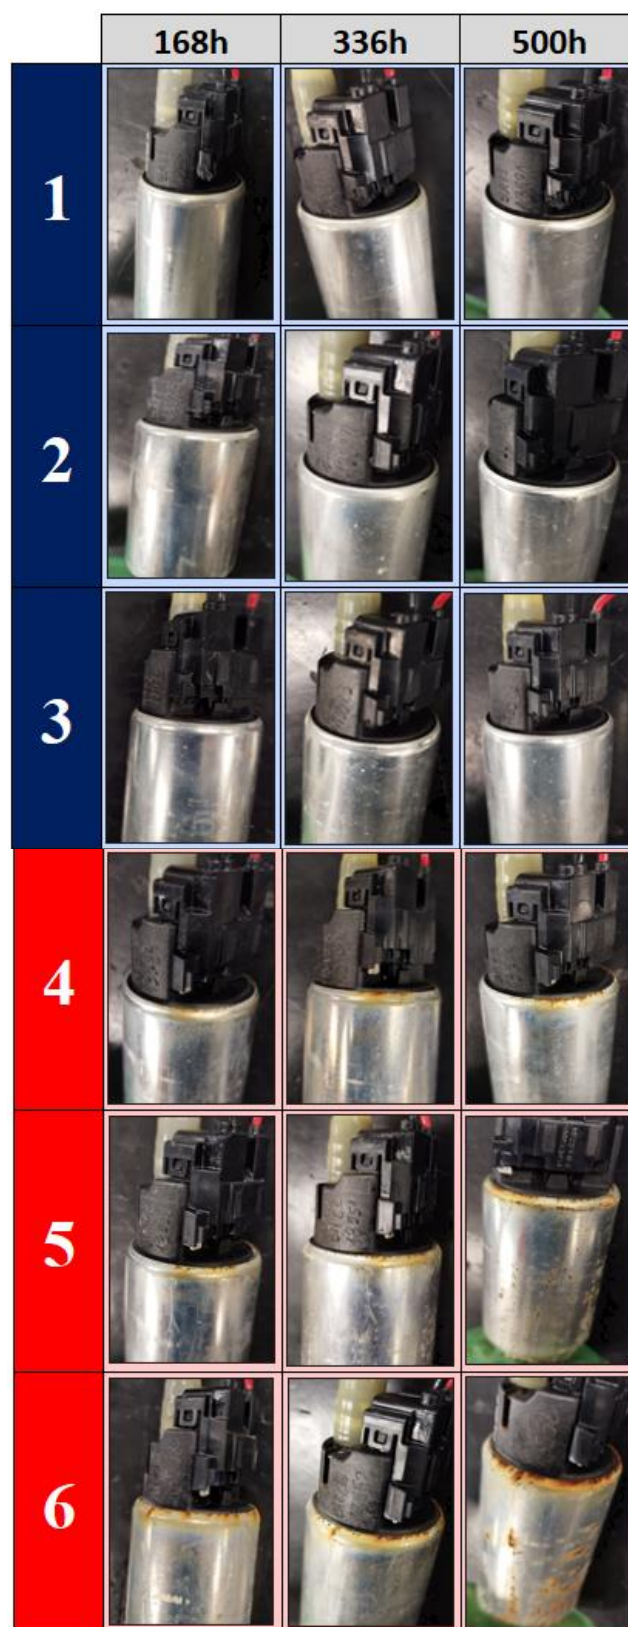
Based on Figure 15, it is evident that corrosion in the parts containing the grounding terminal initially concentrates in the region close to the terminal and gradually spreads over time. One aspect that potentially contributed to the increase in corrosion was the increase in fuel conductivity during the test.

Figure 15. Images of the fuel pump housing captured during the test
